# CRACK PROPAGATION TEST REPORT & FINDINGS

## MUNICIPAL PIPING SYSTEMS

### FUSIBLE BRUTE™

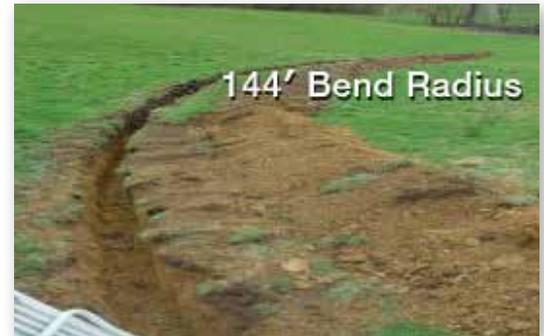
Photo 1: Open cut trench

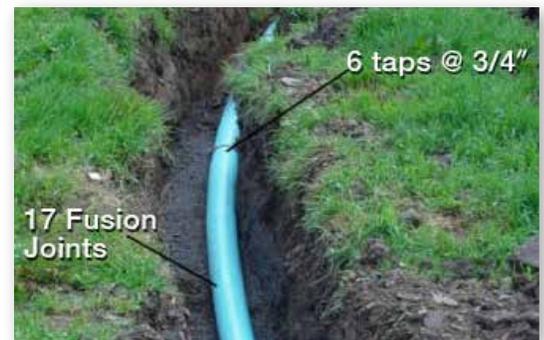
Photo 2: Six 3/4" taps and seventeen fusion joints were installed.

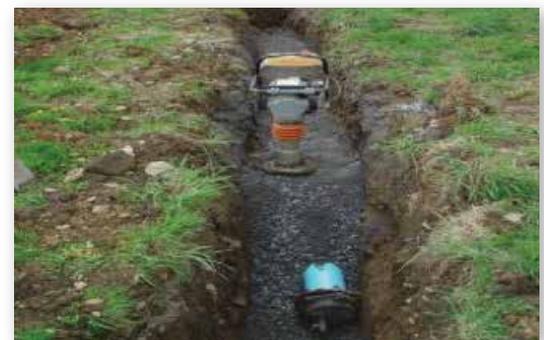
Photo 3: Bedded and covered pipe was capped, filled and pressurized.
