Bionax® Impresses After Encounter With A Directional Drill

Last October, a watermain break changed the perspective of a construction supervisor in Southwestern Ontario.

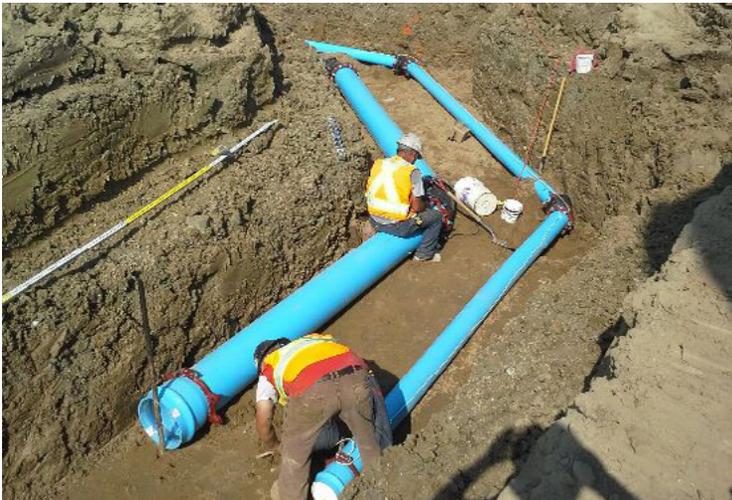
completed and the new watermain commissioned, a 4" gas line was being installed and the contractor drilled directly through the center of the new 12" watermain.

"They hit it head on, and as soon as I got the call, I knew exactly what had happened". Smith rushed over to the site and was immediately met with water gushing out of the ground at the adjacent joints, but only bubbling out of the ground where the conflict was.

"I was really surprised that the Bionax PVCO held together. Had this had been a C900 pipe the damage would have been much more extensive with a bigger mess to clean up". Smith's crew worked fast as they cut out a 6 foot section and tied in the repair with two couplings. "The repair was clean, and easy to complete as the damage was contained within inches of the affected area".
